# Manhole Inspection Summary

Manhole # S41K\_\_038MH

Insp Date: **5/23/08 12:30 PM**

**Location** Address: **across from 725 eden st**

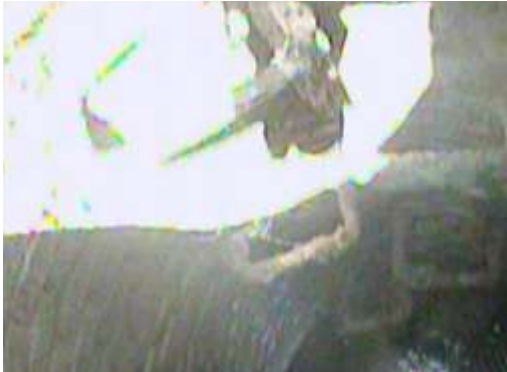
Defect 3

Count: **9** Missing: **1** ☒ **Corroded**

steps

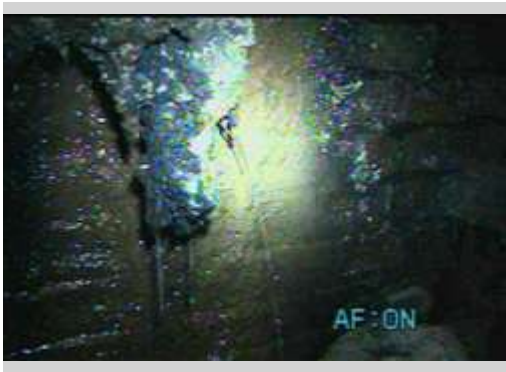
Defect 2

Infiltration: ☐ None ☐ Joint ☐ Cracks ☐ Mortar ☐ Roots ☒ **Wall**

Barrel wall infiltration

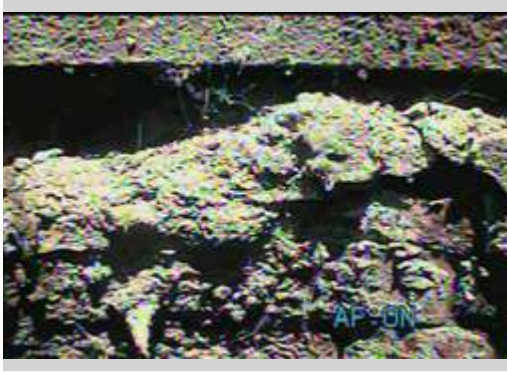
Defect 1

Condition: ☐ Sound ☐ Cracked ☐ Root Intrusion ☐ Loose Brick ☒ **Deteriorated**

corbel det.

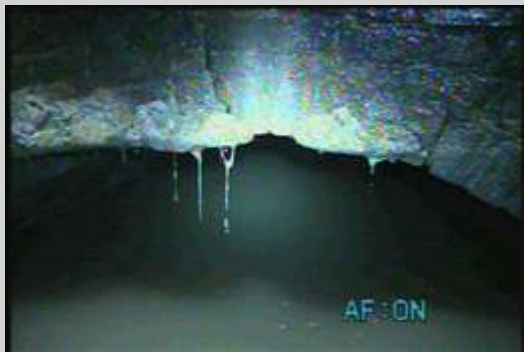
12 O'Clock Outflow

42 in. Circular Gravity Sewer  
Pipe Out @ 12 O'Clock

Pipe Material: **Clay** ☐ Pipe Lined

Invert Depth: **16.36** (ft.) Flow Characteristics: **Fast**

Infiltration: **None** Pipe Seal Cond: **Unknown**

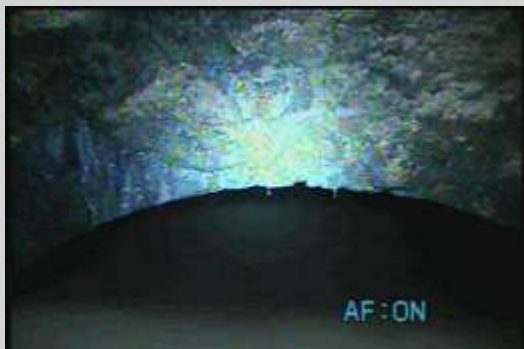
6 O'Clock Inflow

42 in. Circular Gravity Sewer  
Pipe In @ 6 O'Clock

Pipe Material: **Clay** ☐ Pipe Lined

Invert Depth: **16.28** (ft.) Flow Characteristics: **Fast**

Infiltration: **None** Pipe Seal Cond: **Unknown**
